PRODUCT IMPROVEMENT TEST OF

MODIFIED AR15 RIFLES

REPORT NO. DPS-1276

DEVELOPMENT AND PROOF SERVICES
REPORT ON USATECOM PROJECT NO. 8-3-0030-08-F,
PRODUCT IMPROVEMENT TEST OF
MODIFIED AR15 RIFLES
12 NOVEMBER TO 5 DECEMBER 1963

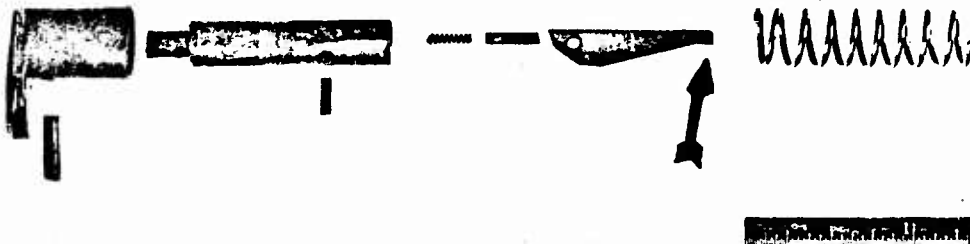
Figure 3: Second Design of Bolt Closure Pawl Assembly. The Pawl Tip and Plunger Spring Have Been Redesigned.
